SOFIE PROJECT - TEST RESULTS ON THE LATERAL RESISTANCE OF CROSS-LAMINATED WOODEN PANELS

SUMMARY

In this paper, results from tests on the lateral resistance of cross-laminated wooden panels are presented. Different configurations of wall panels are investigated by means of ramp and cyclic displacement schedules taking into account the influence of the anchoring system, the opening layout and the inter-storey connection.

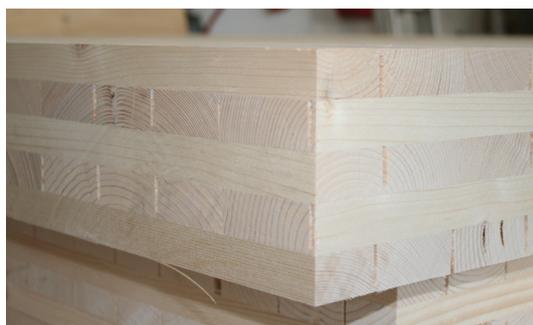
Figure 1: Cross-laminated wooden panel

All tests have been undertaken on a 2.95m wide and 2.95m high wooden panels with cross interlayers (see Fig. 1 for material). All panels have 5 layers of 17mm thickness each resulting in a panel thickness of 85mm – which is a standard panel for wall elements of 2-3 storey buildings.

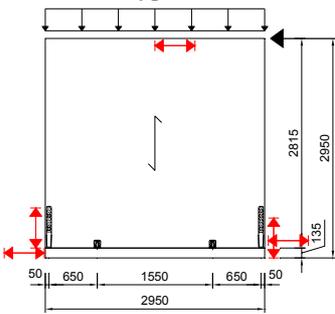
<p>Vertical load:</p>	<p><i>Configuration A</i></p> <p>2.95m by 2.95m without opening</p> <p>Connection to base with three BMF angles 90x48x3.0x116 and two holdowns</p> <p>Holdown anchors in the first test <i>1</i> (see Table 2) has been “home made”. The tests 2 and 3 have been carried out with a standard holdown HTT22 by SIMPSON BMF.</p> <p>Annular ringed shank nails 4x60 are used to fasten the steel connectors to the panel. The quantity of nails between tests 2 and 3 has been changed in order to control failure occurring either in the holdown anchors or in the nail connection.</p> <p>All other connections (upper connection to steel beam and connection to steel base) are designed to be very strong such that they are allowing for any slip.</p> <p>18.5kN/m (based on the 1st storey wall of a real three storey building)</p>
<p>Panel dimension:</p> <p>Connection type:</p>

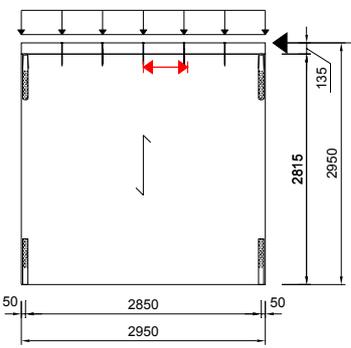
<p>Vertical load:</p>	<p><i>Configuration B</i></p> <p>2.95m by 2.95m without opening; included a floor slab of 135mm underneath the wall panel</p> <p>Inter-storey connection (floor to upper wall) with two BMF angles 105 with reinforcement and two standard holdowns HTT22 by SIMPSON BMF</p> <p>Annular ringed shank nails 4x60 are used to fasten the steel connectors to the panel. As in the test <i>1</i> the nails fixing the steel angle to the floor slab were pulled out, two additional screws were used in test 2.</p> <p>All other connections (upper connection to steel beam and floor slab connection to steel base) are designed to be very strong such that they are not allowing for any slip.</p> <p>10.2kN/m (based on the 2nd storey wall of a real three storey building)</p>

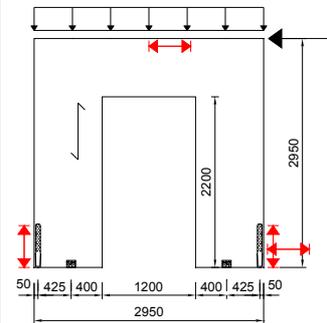
<p>Vertical load:</p>	<p><i>Configuration C</i></p> <p>2.95m by 2.95m without opening; included a floor slab of 135mm on top of the wall panel</p> <p>Inter-storey connection (floor to lower wall) with inclined screws 8x260 and two standard holdowns HTT22 by SIMPSON BMF</p> <p>Annular ringed shank nails 4x60 are used to fasten the holddown to the panel. It must be stated though that in this test configuration with the floor slab being on top of the wall, no uplift forces are occurring. Only the shear connection was tested.</p> <p>The base connection and the connection of the floor slab to the upper steel beam are designed to be very strong such that they are not allowing for any slip.</p> <p>18.5kN/m (based on the 1st storey wall of a real three storey building)</p>

2.95m by 2.95m with a 1.20m or 1.80m by 2.20m central door opening

Connection to base with two BMF angles 90x48x3.0x116 and two standard holdowns HTT22 by SIMPSON BMF
Annular ringed shank nails 4x60 are used to fasten the steel connectors to the panel.
All other connections (upper connection to steel beam and connection to steel base) are designed to be very strong such that they are not allowing for any slip.

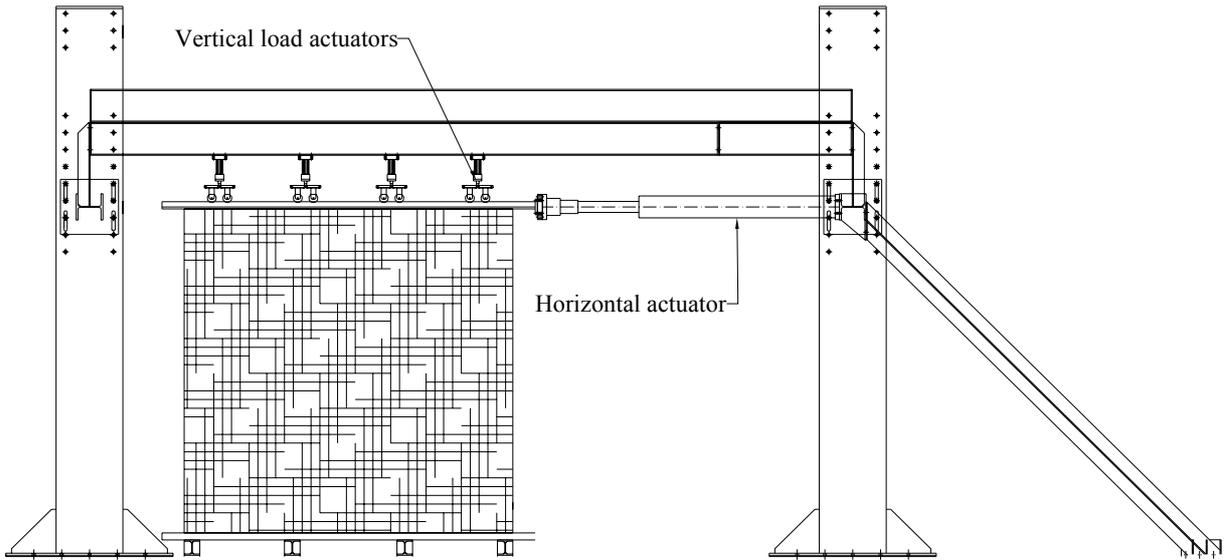
Figure 2 shows the test set-up with the actuator used to undertake ramp and cyclic testing.

Figure 2: Test Set-up. For sake of simplicity upper stabilizing transverse steel beams are not reported.

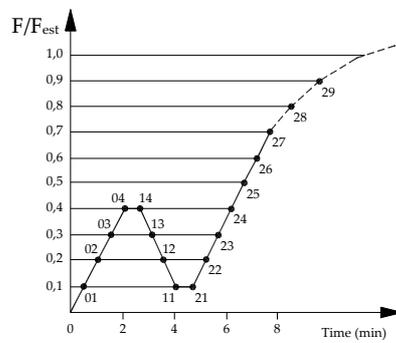
The ramp monotonic tests were performed according to EN26891 “*Timber structures – Joints made with mechanical fasteners – General principles for the determination for strength and deformation characteristics*” in displacement control at a rate of 0.04 mm/s. EN26891 is applied with a constant displacement control and not under load control as required in the document.

Figure 3: Test Protocol EN26891 [1]

The following Figures 3 and 4 show the test protocols.

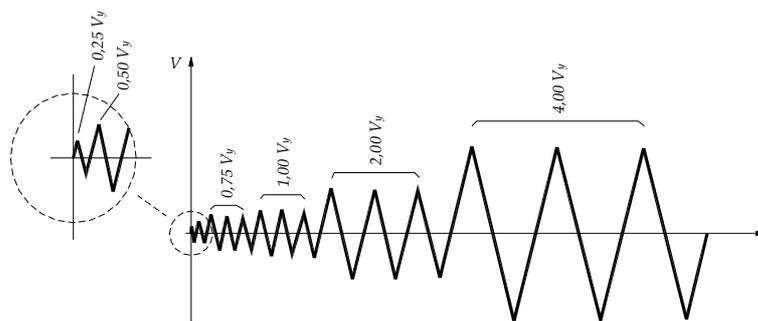
The reversed cyclic tests were performed according to EN12512 “*Timber structures – Test methods – Cyclic testing of joints made with mechanical fasteners*” in displacement control at a rate of 0.04 mm/s.

Figure 4: Test Protocol EN12512 [2]

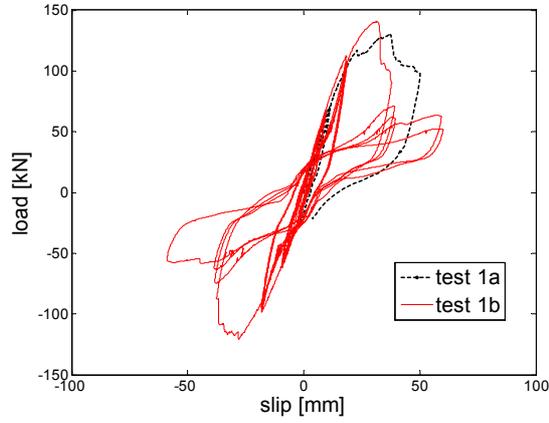
The following figures show the test results in terms of load-slip curves. The displacement shown is the displacement of the actuator and not the displacement of the transducers. The displacement has been cleaned from any other error as relative slip between wall specimen with connections to be tested and the test stand.

Figure 5: Configuration A, ramp and cyclic test 1

The test results are summarized in Table 3. In Configuration A, as it was expected, a stiffer holdown connection (with a 8 mm thick steel plate instead of the 3 mm of thickness of the BMF HTT22) lead to a higher lateral load carrying capacity but a lower ultimate displacement and a less ductile behaviour. In Configuration B the first test (B/1) showed a quite big impairment of strength (about 35% as it can be observed in Fig. 8) due to the pulling out of nails connecting the steel angle to the floor slab during cyclic test (Figure 15). Therefore in test B/2 2 two screws were inserted instead of the first two nails obtaining a significant reduction of the above mentioned impairment of strength. In Configuration C a preliminary test was carried out with 15 inclined screws proved to be too rigid. Hence, for the test 1 carried out, 9 screws were used which gave the system the ductility necessary. In Configuration D it was proved that no holdowns at the opening are necessary due to the high stiffness of the panel material.

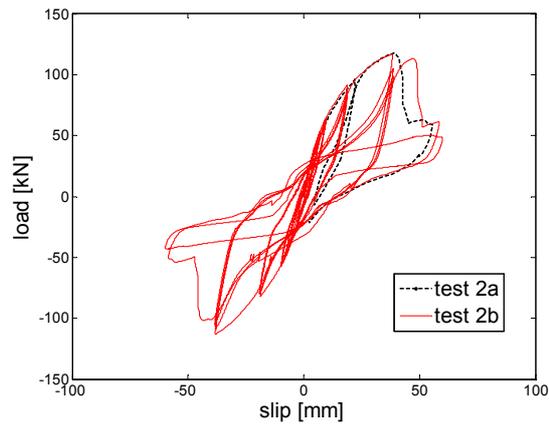
Figure 6: Configuration A, ramp and cyclic test 2

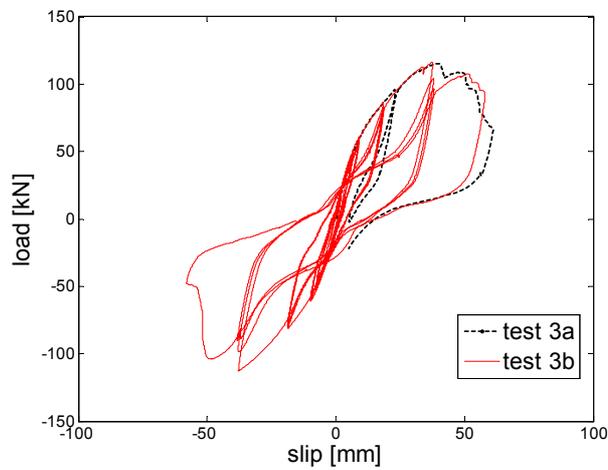
Figure 7: Configuration A, ramp and cyclic test 3

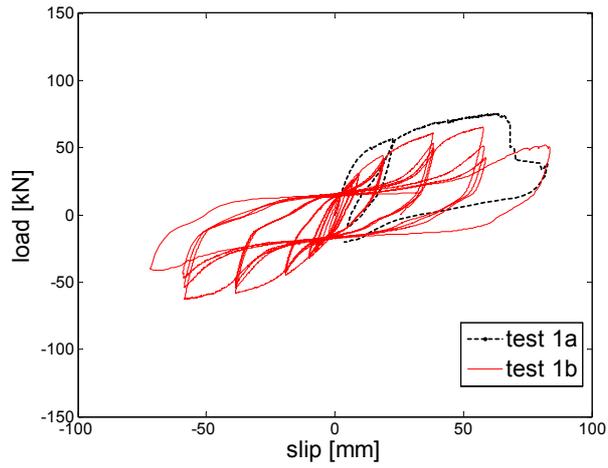
Figure 8: Configuration B, ramp and cyclic test 1

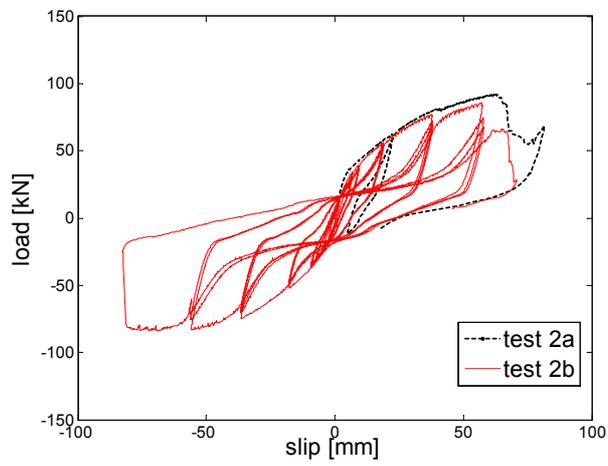
Figure 9: Configuration B, ramp and cyclic test 2

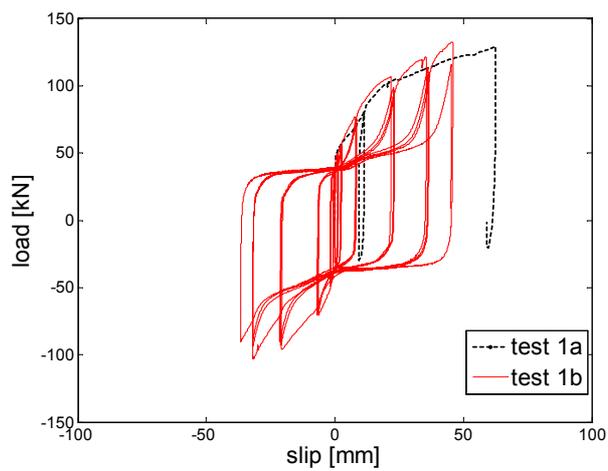
Figure 10: Configuration C, ramp and cyclic test

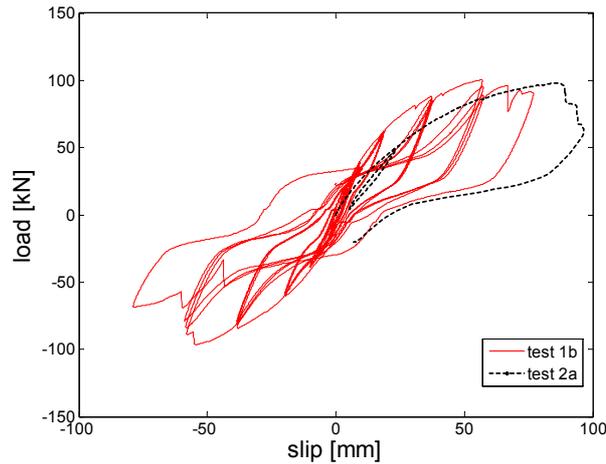
Figure 11: Configuration D, ramp and cyclic test

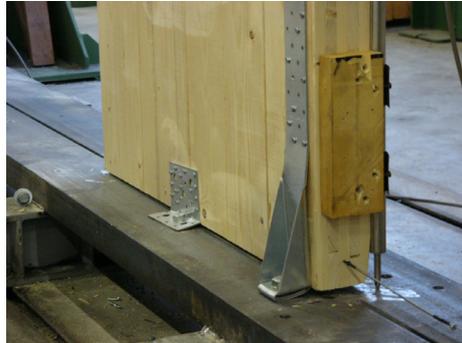
Figure 12: rigid panel with gap (D/1b)

The layout and design of the joints is influencing strongly on the overall behaviour of the structural system. All forces and displacement are concentrated on a rather small region of the panel which is then leading to local failure phenomena as shown in Figure 13 and Figure 15. The wooden panels behaved almost completely rigid.

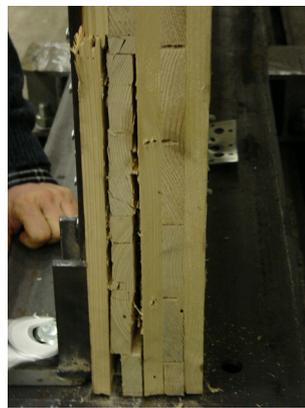
Figure 13: local failure (A/1b)

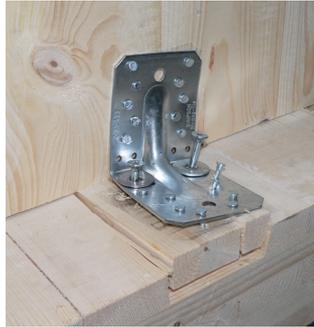
Figure 15: local failure(B/1b)
