# Seismic Behaviour of Multi-Storey XLam Buildings

**Ario Ceccotti**  
Professor  
Director  
ario.ceccotti@ivalsa.cnr.it

**CNR-IVALSA**  
Via Biasi, 75  
38010 San Michele all'Adige (TN)

In this paper results from shaking table tests on a full-scale 3 storied XLam building are presented. The test were conducted at the NIED Tsukuba Shaking Table facility in June and July of 2006. It is the first time that such a test have been ever conducted on this type of structures.

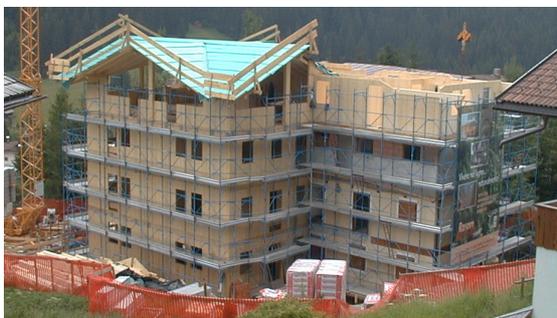
*Fig. 1 Four stories XLam building*

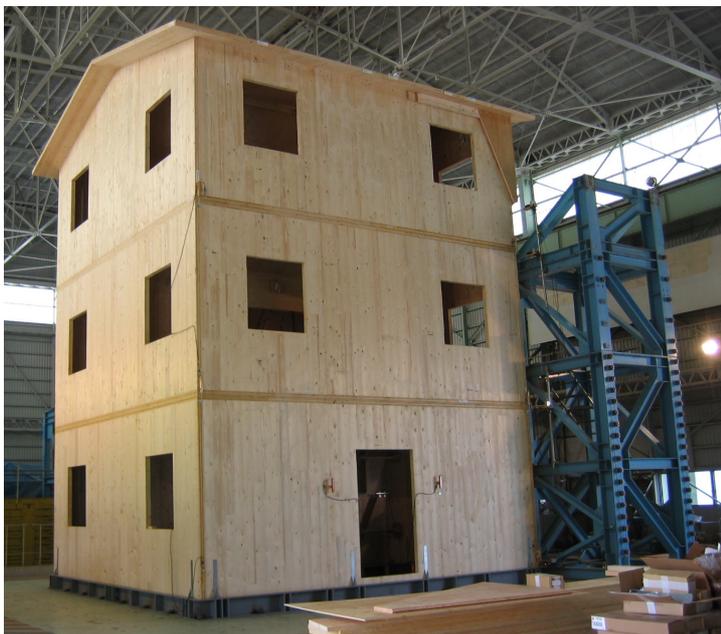
The test specimen was a 3 stories house of about 7 m x 7 m in plan and 10 m of total height with a pitched roof, as illustrated in Figures 2 and 3. The panels were made with spruce coming from the woods of the Val di Fiemme, Trentino in the North East of Italy and were delivered from Italy to Japan. The house was built and dismantled after the tests directly on the shaking table by a team of Italian and Japanese carpenters.

The connection to the shaking table was made by means of a steel frame made of H 300x300x10x15 profiles according to JIS G 3192: 2000 which was itself connected to the shaking table by means of ø50 bolts. The house was connected to the steel base with commercial type holdown anchors and steel angles.

Fig. 3 The test house on the shaking table

In order to study the behaviour of this construction system with reference to the length of resisting walls and the torsional behaviour in case of asymmetric layout of stiffnesses, three different phases of the test have been planned, named respectively Phase A, B and C with three different opening layouts in the two external wall parallel to the shaking direction. For each phase the building was tested with 3 different earthquakes (Kobe, El Centro and Nocera Umbra) at 2 growing levels of PGA (0.15g and 0.5g) as showed in Fig. 3 and 10.

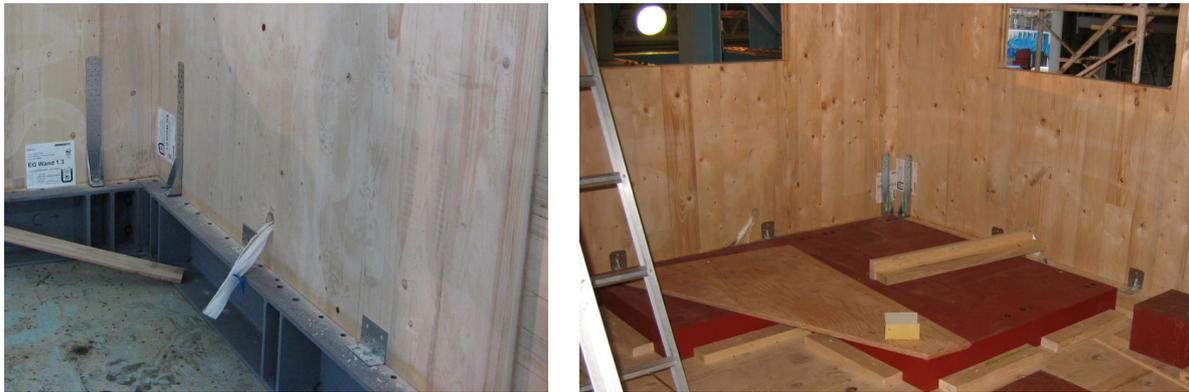
The same screws were used in the vertical joints between perpendicular walls and to connect floor panels to the walls below as showed in Fig. 5. The connection to the steel base was made by means of commercial type holdown anchors (Simpson StrongTie HTT22 connected to the basement by means of 8.8 Class M16 anchor bolts and with  $\varnothing 4$  annular ringed nails to the walls) placed at wall endings and at door openings and steel angles (BMF 90x48x3x116 connected to the basement by means of 8.8 Class M12 anchor bolts and with  $\varnothing 4$  annular ringed nails to the walls) distributed along the length of each wall. The inter-storey connection between walls and floor was made again with holdown anchors at corners (Simpson StrongTie HTT16, two of them placed above and below

the floor panel and connected together by means of 8.8 Class M16 anchor bolts and with ø4 annular ringed nails to the walls) and steel angles distributed along the length of each wall (BMF 90x48x3x116 connected to the floor and to the walls with ø4 annular ringed nails).

Fig. 6 Holddown anchors and steel angles used to connect wall panels to the steel base and to the 1<sup>st</sup> floor.

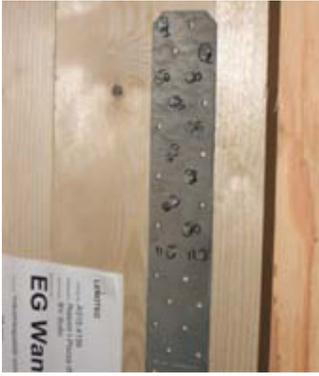
This strategy was pursued even in each single connection in order to reach for the whole structure the maximum ductility and energy dissipation as possible, starting from the results of tests on connections and in-plane monotonic and cyclic tests with different connection layouts preliminary held in Italy. For instance the holddown connection to the basement was calculated with 12 nails, not more not less, placed randomly in the upper side of the holddown connection in order to reach a higher dissipation of energy due to the plasticization of the steel in the holddown anchor.

Following the same strategy the holddown connections at 2<sup>nd</sup> floor had 9 nails and 5 nails at 3<sup>rd</sup> floor.

Fig. 7 Holddown connection to the steel base with 12 nails.

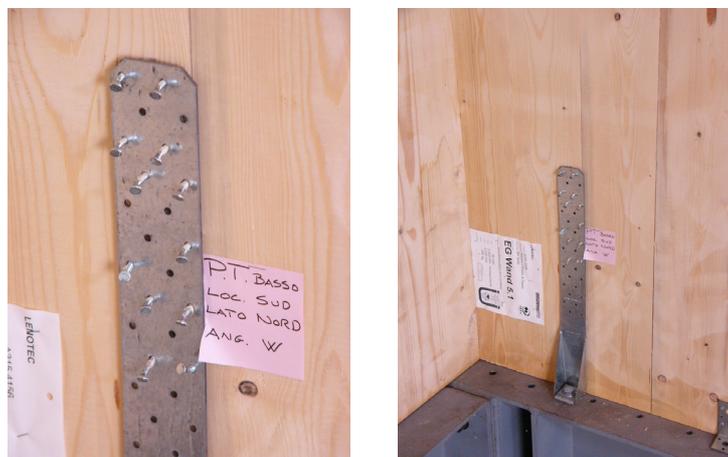
Fig. 12 Holdown failure after Nocera Umbra 1,2g test.

Record	Code	PGA [g]	Restoring intervention (before the test)	Observed damage (after the test)
Nocera Umbra	06070510	0.50	Tightening of holdown anchor bolts Replacing of screws in vertical joints between panel	None
El Centro	06070515	0.50	Tightening of holdown anchor bolts.	None
Kobe	06070714	0.50	Tightening of holdown anchor bolts Replacing of screws in vertical joints between panel	None
Kobe	06070709	0.80	Idem	Slight deformation of screws in vertical joints between panels
Kobe	06070714	0.50	Idem	None
Kobe	06070719	0.50	Tightening of holdown anchor bolts	None
Kobe	06071006	0.80	Replacing of holdown anchors and tightening of bolts. Replacing of screws in vertical joints between panel	Slight deformation of screws in vertical joints between panels
Nocera Umbra	06071009	1.20	Tightening of holdown anchor bolts. Replacing of screws in vertical joints between panel	<b>Holdown failure</b> and deformation of screws in vertical joints between panels
